Case Study – Identifying Acoustic Leaks, St Andrews Hall, Norwich, UK

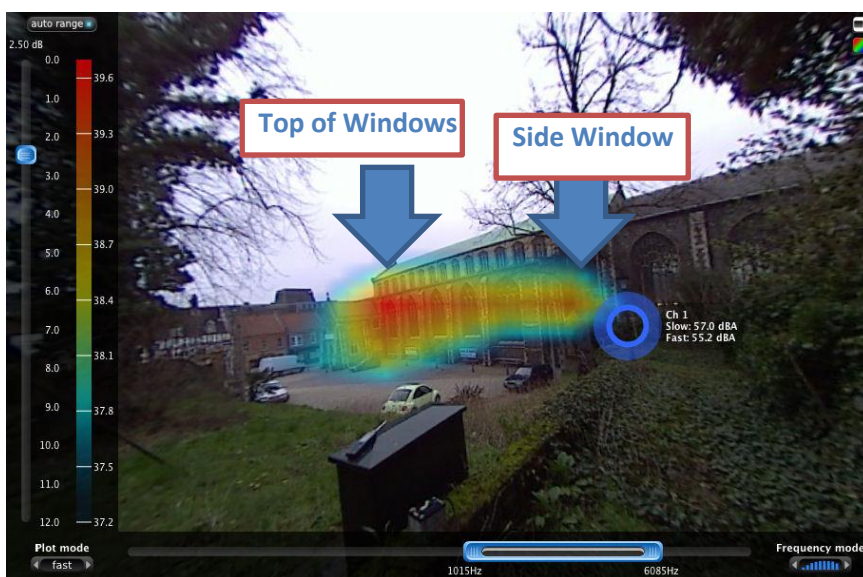
Figure 2 – Acoustic camera image from distance

Two main areas could be seen where sound was leaking from the hall. The first was a side window closest to the camera in figure 2. The second was from the top of the windows on the main façade. In order to identify this the acoustic camera was moved closer to the hall.

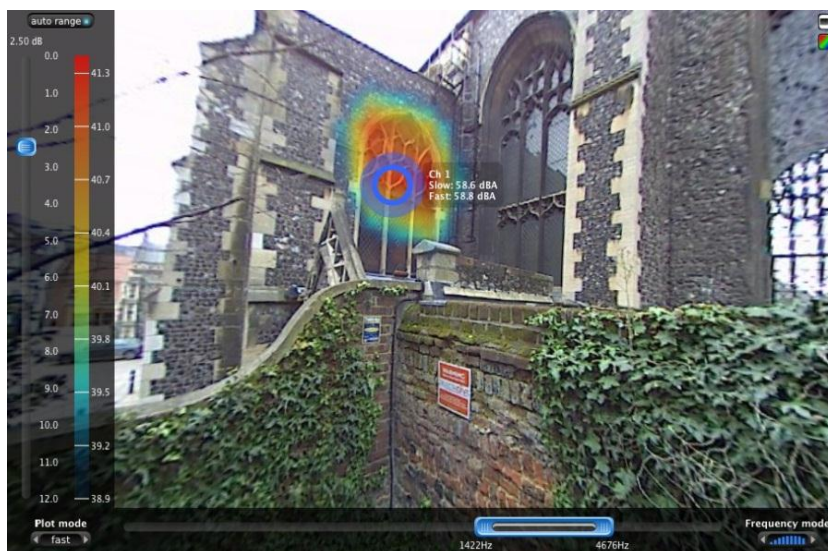
Figure 3 – Acoustic camera image of side window

The camera was placed approximately 5m from the side window. This window shows an obvious acoustic leak as can be seen in figure 3. This window has not received secondary glazing and from the acoustic camera it can be seen it has a significant contribution to the sound level at the nearest residential receptors. An improvement would be seen if this window was secondary glazed.

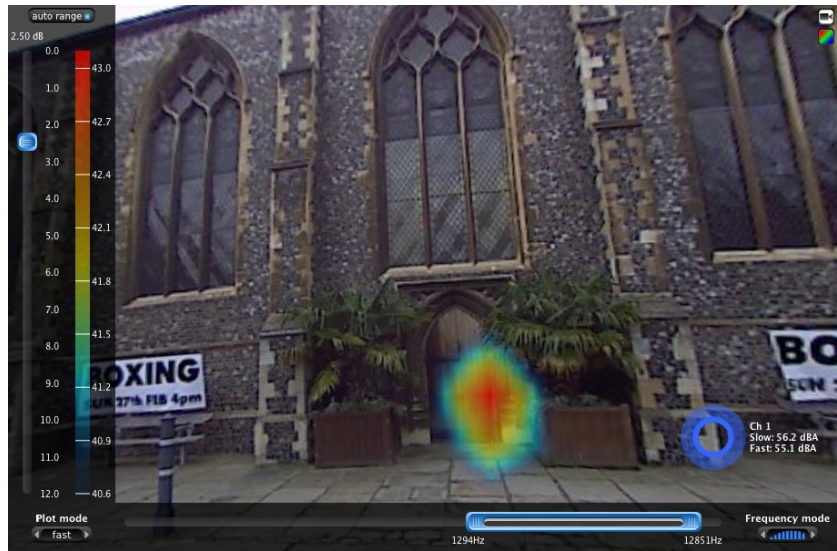
Figure 5 – Seal missing on external door

The inner acoustic door was closed and the external door closed fully. From 1kHz onwards a leak could be seen in figure 4 where the seal was missing on the external door (figure 5). On the internal acoustic door it was discovered that there was a seal missing as can be seen in figure 6.

Fixing these seals would improve the sound insulation with minimal cost.

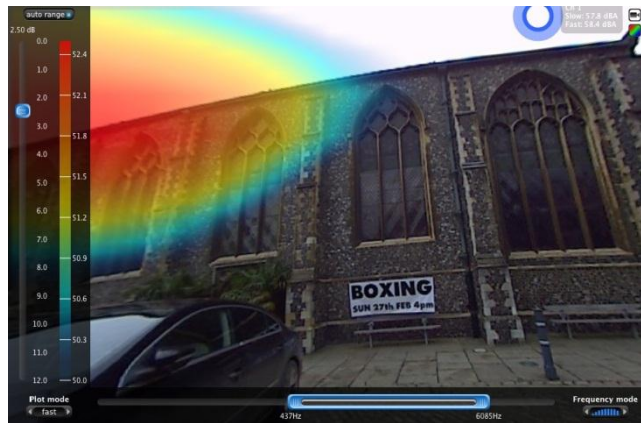
Figure 7 – measurement at main façade

Placing the acoustic camera close to the main façade it could be seen that the sound was leaking from the far end of the building. This can be seen in figure 7.

By using the virtual microphone with the camera (the blue circle seen on the screen) it can be placed on any part of the screen to hear this area in isolation. A significant leak could be heard and seen to the far end of the building. Notice the bird on the video file?

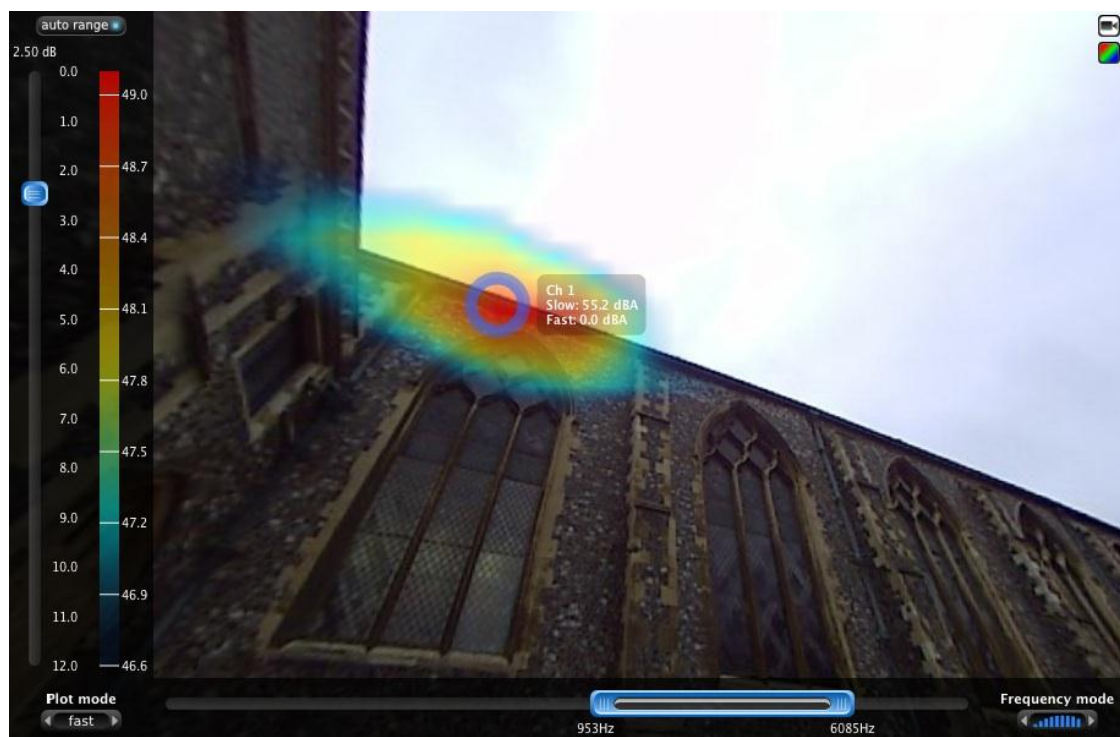
Figure 8 – Acoustic leak pinpointed

The acoustic camera was placed close to the façade at the far end of the building and significant acoustic leak was identified above the window on the far end of the building.

The construction of the building is masonry with large wooden beams laid across the top of the walls to support the roof. The leak could be pinpointed to a major beam located above the window in figure 8 above. Of the leaks detected this is the most significant acoustic leak at the hall and the

main contributor to higher levels than expected at the receivers. To a lesser extent a leak was detected on the second window from the left in figure 8.

The main leak above in figure 8 needs further investigation. A cherry picker/ working platform is required to access the pin pointed areas. It is likely that repairing the masonry will improve the sound insulation significantly.
