Case Study – Identifying Acoustic Leaks, St Andrews Hall, Norwich, UK

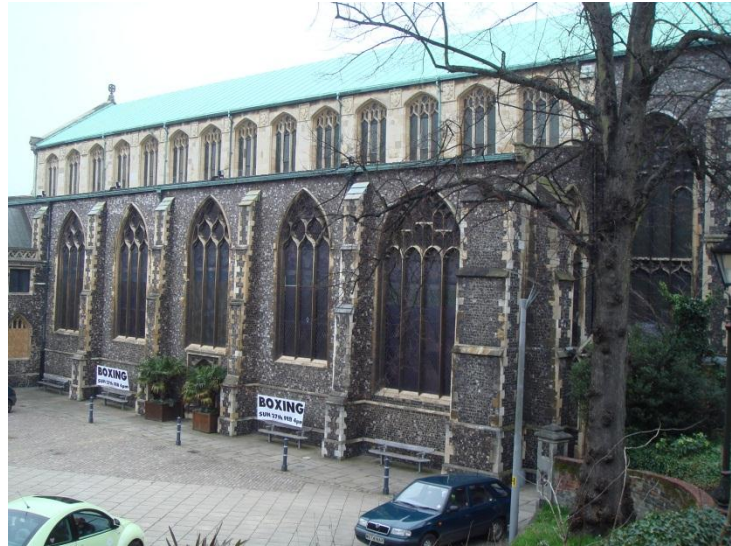
Figure 1 – St Andrews Hall

In order to reduce break out noise secondary glazing has been installed on the first and second floor of the hall opposite the flats. These windows can be seen in figure one below. In addition the main entrance to the main hall was given an acoustic seal and an internal acoustic door has been installed.

The result of the acoustic treatment is approximately 1dB improvement at the nearest noise sensitive property.

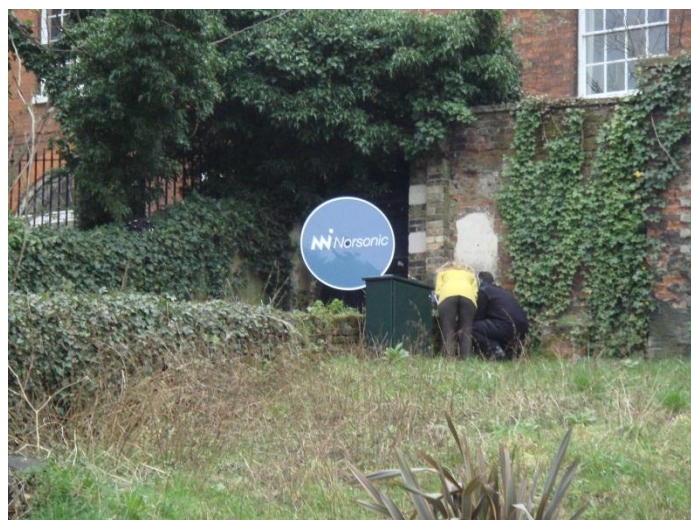
In order to identify acoustic leaks on the main façade as shown in figure 1 additional loudspeakers were placed in the hall playing pink noise to give an internal reverberant sound pressure level of 105dB(A). The acoustic camera was then pointed towards the façade to see if leaks could be detected.
